# HEAD LIGHT COMPONENTS

65091-01

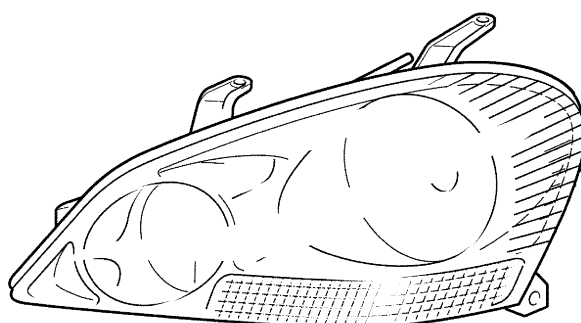
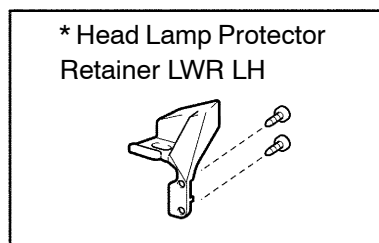
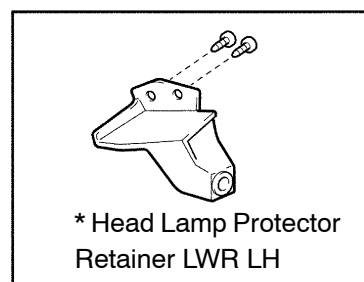
\* : When only the installation part of the headlight unit assy LH is damaged, it can be repaired inexpensively by using a bracket provided for repair. In this case, however, the headlight unit assy LH itself should not be damaged.
