# TOYOTA Technical Service BULLETIN

## FRONT BRAKE GROAN NOISE

'01 RAV4

RECEIVED  
BR007-01  
BRAKE

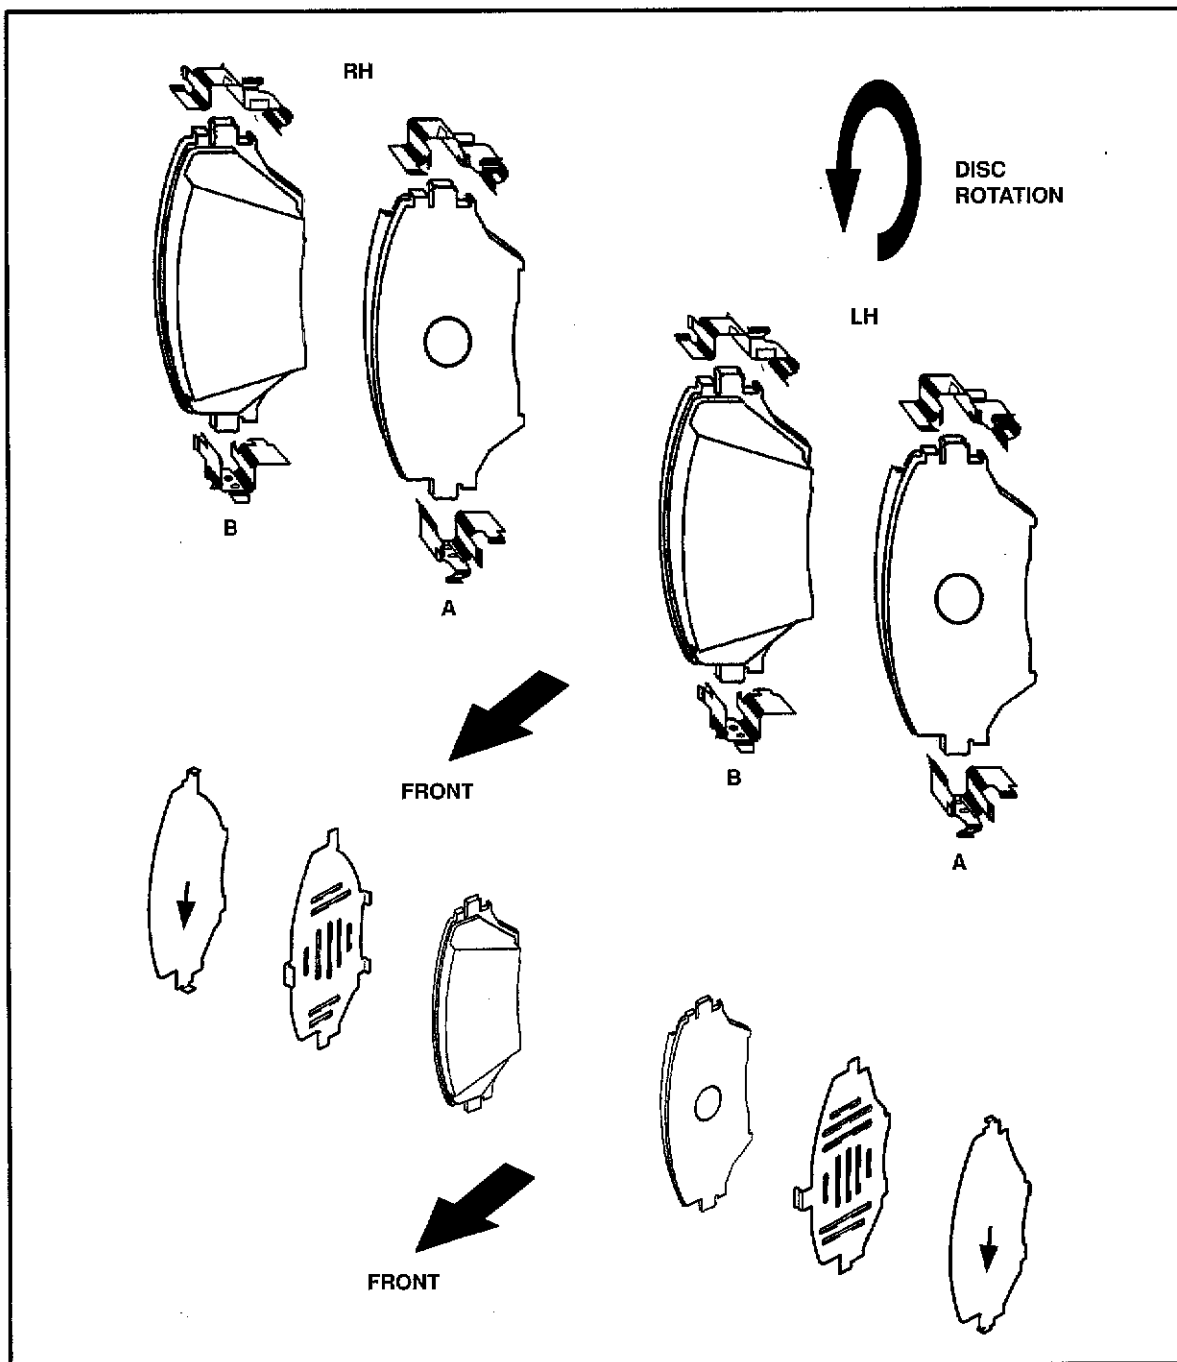
**Installation  
Procedure****Front Brake Pad Installation****NOTICE:**

- Make sure that pad A and pad B are correctly installed.
- Make sure to install the shims so that the arrow mark on the shim matches the direction of disc rotation.

If the customer encounters a front brake groan noise, replace the front brake pads (see 2001 RAV4 Repair Manual page BR-23, Pub. No. RM 797U2).
