Title:
WIND WHISTLE FROM FRONT EDGE
OF HOOD
Models:
'02 RAV4

SB629481

NV004-02

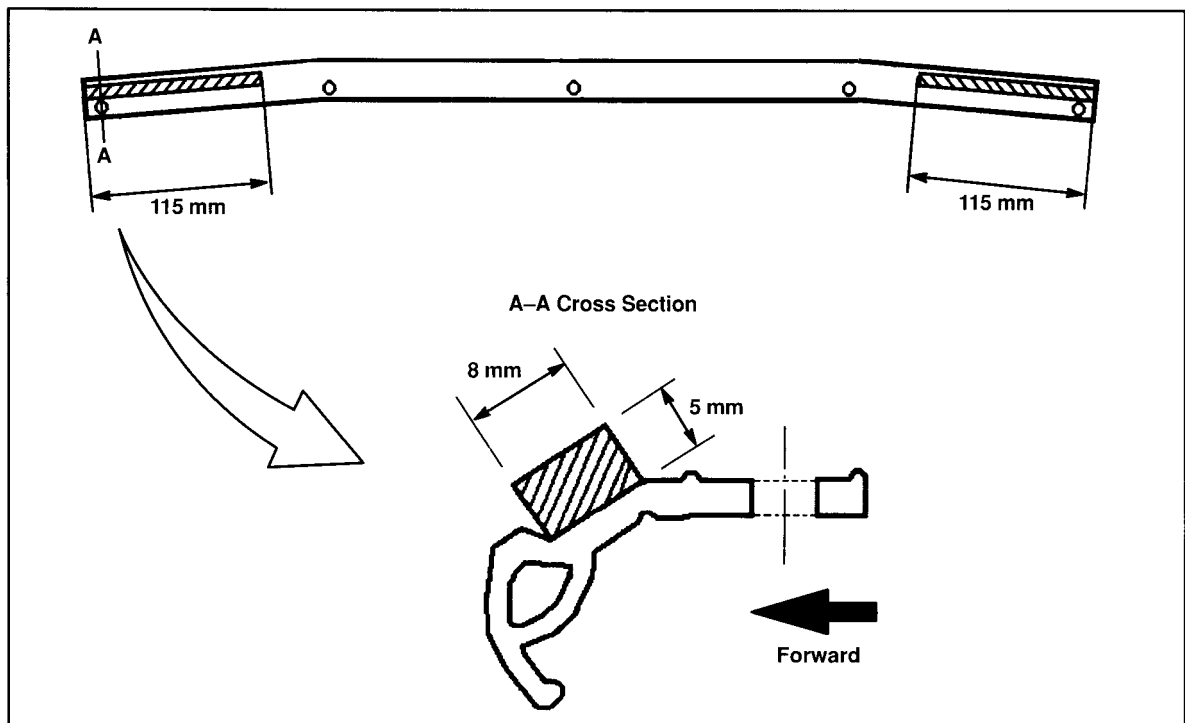
2. Cut two pieces of EPT sealer from the wind noise kit, and apply them to the hood seal as shown.

EPT Size**Length: 115 mm****Width: 8 mm****Thickness: 5 mm**

3. Reinstall the hood seal.
