Introduction The following information is provided to supplement the Repair Manual procedure for removing/installing the steering gearbox or rack and pinion on vehicles equipped with a driver's side Supplemental Restraint System (SRS) Airbag.

Affected Vehicles Tercel, Paseo, Corolla, MR2, Celica, Camry, Avalon, Supra, Previa, Sienna, RAV4, 4Runner, Tacoma, T-100 & Land Cruiser equipped with a driver's side SRS Airbag.

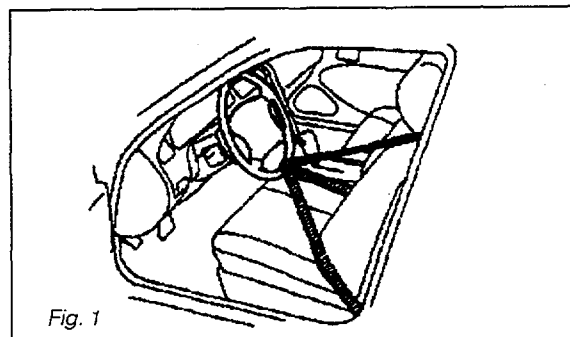
1. Position the front wheels facing straight ahead.
2. Using the driver's seat belt, set the steering wheel so that it does not turn (see Fig. 1).

When the intermediate shaft is disconnected and the steering wheel is turned freely, the SRS spiral cable may be broken. Therefore, as a precaution, make sure to pass the driver's seat belt through the steering wheel to prevent it from turning freely, as shown below.

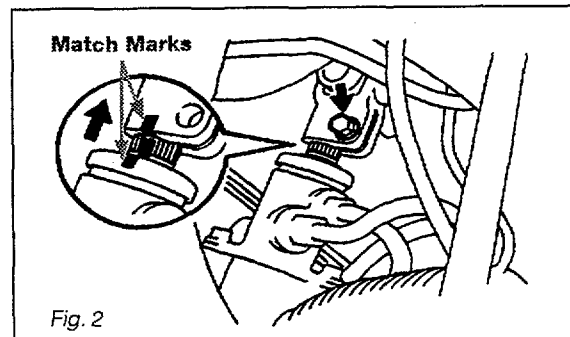
3. Paint match marks on the intermediate shaft and control valve shaft (see Fig. 2).
4. Remove the intermediate shaft retaining bolt and disconnect the intermediate shaft (see Fig. 2).
