# RADIO BROADCAST CANNOT BE RECEIVED (POOR RECEPTION)

## INSPECTION PROCEDURE

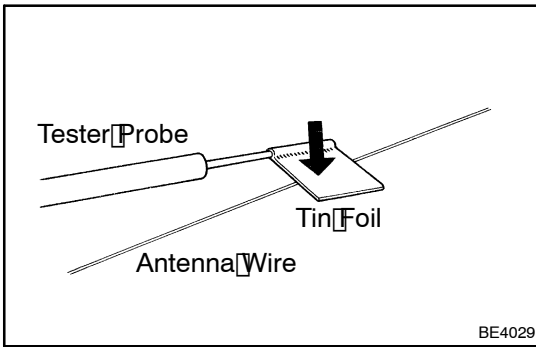
#### 4 CHECK ANTENNA ASSY

(a) Check for continuity of the antenna.

HINT:

Inspect the continuity at the center of each antenna wire, as shown in the illustration.

**NOTICE:**

When cleaning the glass, use a soft dry cloth, and wipe the glass in the direction of the wire. Take care not to damage the wires. Do not use detergents or glass cleaners with abrasive ingredients. When measuring voltage, wind a piece of tin foil around the top of the negative probe and press the foil against the wire with your finger, as shown in the illustration.

OK: There is continuity in the antenna.
