# TELEVISION CAMERA ASSY REPLACEMENT

6719T-01

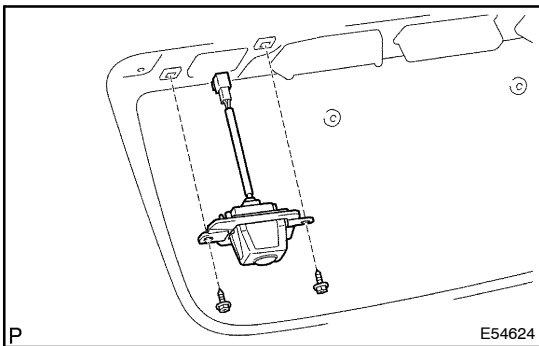
## 8. REMOVE TELEVISION CAMERA ASSY

- (a) Disconnect the connector.
- (b) Remove the 2 screws and television camera assy.
