# RADIO RECEIVER ASSY REPLACEMENT

6705V-01

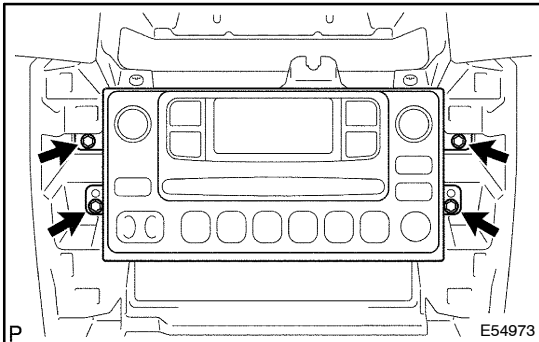
## 4. REMOVE RADIO RECEIVER ASSY

- (a) Remove the 4 screws.
- (b) Disconnect the connectors and remove the radio receiver assy.

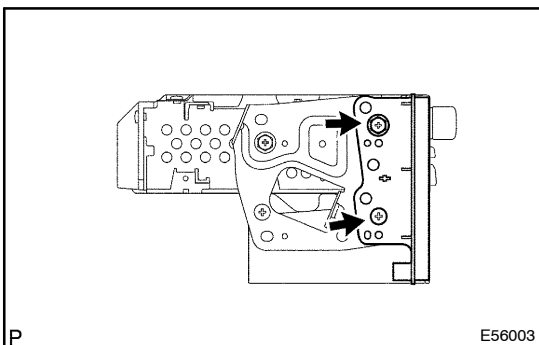
## 5. REMOVE RADIO RECEIVER PANEL

- (a) Remove the 2 screws and radio receiver panel.

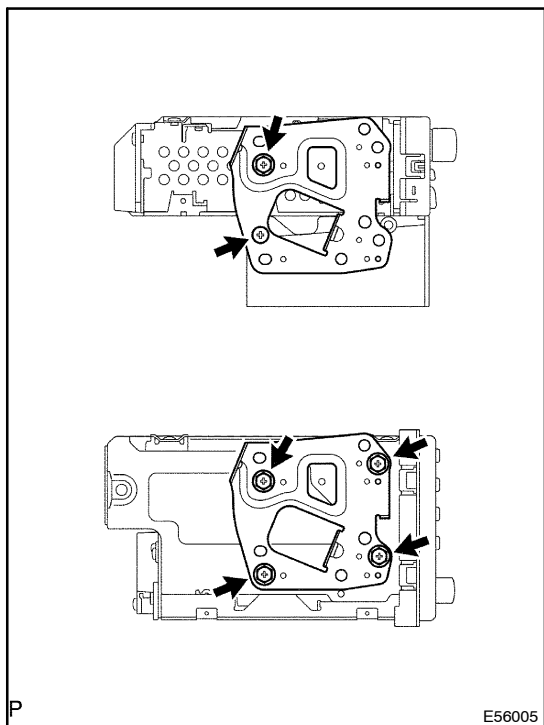
**7. REMOVE RADIO BRACKET NO.1**

- (a) Remove the 2 screws and radio bracket No.1. (w/ stereo opening cover)
- (b) remove the 4 screws and radio bracket No.1. (w/ stereo opening cover)

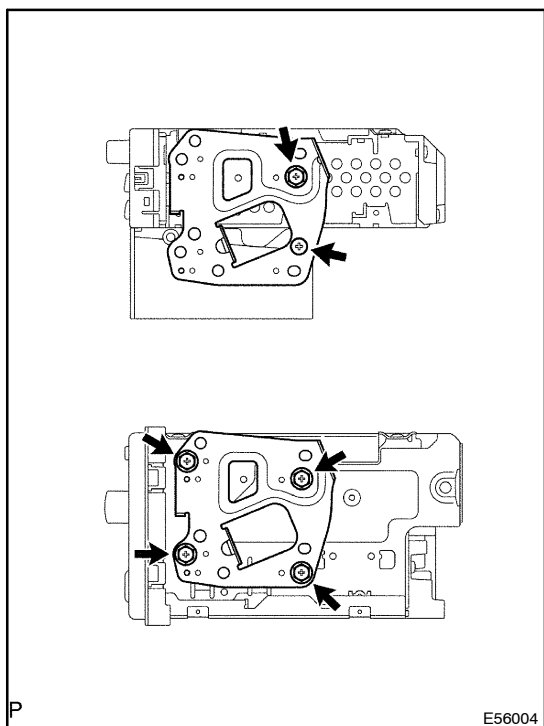
**8. REMOVE RADIO BRACKET NO.2**

- (a) Remove the 2 screws and radio bracket No.1. (w/ stereo opening cover)
- (b) Remove the 4 screws and radio bracket No.1. (w/ stereo opening cover)
