# Technical Service BULLETIN

## FRONT DOOR LOCK KNOB OPERATION

'98 RAV4

BO022-98

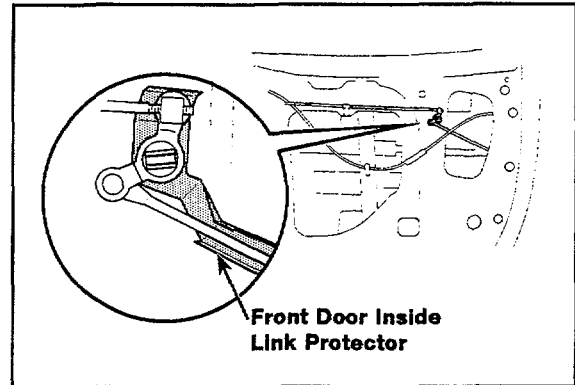
**Introduction** To improve door lock operation "feel" by minimizing free-play at the bell crank pivot, the shape of the Front Door Inside Link Protector has been changed for 1998 RAV4 models.

2. Remove original locking link protector  
and replace with modified part.
