Technical Service BULLETIN

ECU FLASH REPROGRAMMING ERROR MESSAGE

SS004-01

September 23, 2003: Models added – 2002 (and later) Solara, 2003 (and later) Corolla and Matrix, and 2004 models; Test Procedures updated for new CAN Interface Module. The previous TSB should be discarded.

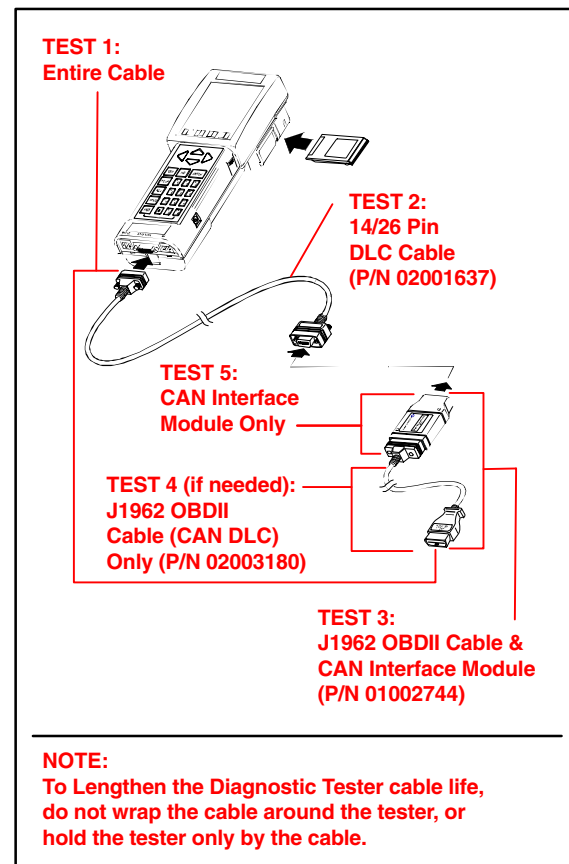
During ECU flash reprogramming, the Error screen at right may be displayed on the Diagnostic Tester for one of the following reasons:

1. Immobilizer key not properly registered or auto-registration mode left open.
2. Ignition ON/OFF cycling not followed correctly during the flash reprogramming procedure.
3. The Diagnostic Tester cable is damaged, causing an open communication circuit.

**UPDATE ECU CAL
CANNOT CHANGE TO
REPROGRAM MODE
PLEASE CHECK**

- IG TURNED OFF/ON PROPERLY
- ALL KEY CODES REGISTERED

PRESS [ENTER]

To eliminate the possibility of the first 2 reasons causing the error message, do the following:

1. Confirm the Immobilizer Transponder Master Key is properly registered and auto registration mode is closed. Follow the appropriate Repair Manual procedure and consult TSB SS001–99, “*Scantool Immobilizer Key Code Utility.*”
2. Conduct the ECU flash reprogramming process explicitly following key operation instructions. Refer to TSB SS002–01, “*ECU Flash Reprogramming Process,*” for more details.

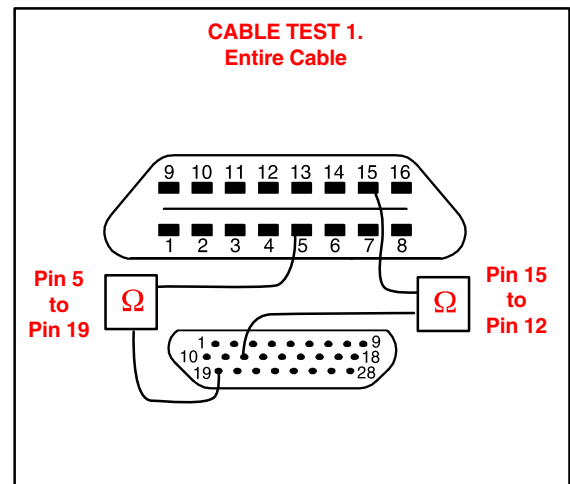
CABLE TEST 1.

- A. Connect Diagnostic Tester cables DLC (P/N 02001637) and CAN Interface Module / J1962 OBDII together (P/N 01002744).
- B. Test for continuity.
 - If there is continuity, the cable is OK. Check steps 1 and 2 above to complete the flash reprogramming process.
 - If there is no continuity, proceed to CABLE TEST 2.

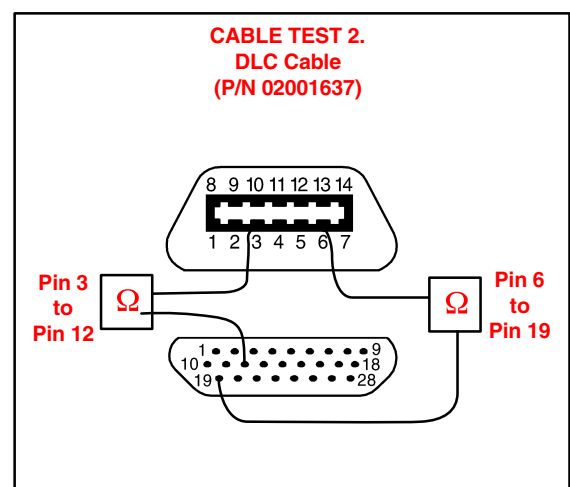
CABLE TEST 2.

- A. Disconnect Diagnostic Tester cables DLC (P/N 02001637) and CAN Interface Module / J1962 OBDII (P/N 01002744).
- B. Test DLC cable (P/N 02001637) for continuity.
 - If there is continuity, the cable is OK. Proceed to CABLE TEST 3.
 - If there is no continuity, the cable needs to be replaced.

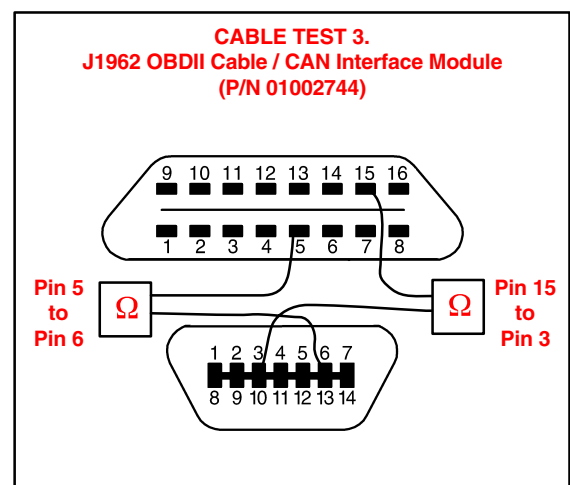
CABLE TEST 3.

- A. Test J1962 OBDII / CAN Interface Module (P/N 01002744) for continuity.
 - If there is continuity, the cable and CAN Interface Module are OK. Re-check Cable Tests 1, 2, and 3 while wiggling and flexing the cables.
 - If there is no continuity, proceed to CABLE TEST 4.

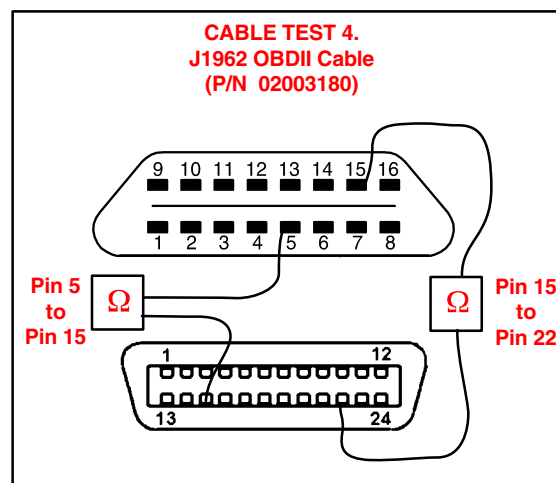
CABLE TEST 4.

- A. Disconnect the CAN Interface Module (P/N 01002744) from the J1962 OBDII cable using a Phillips screwdriver.
- B. Test J1962 OBDII cable (P/N 02003180) for continuity.
 - If there is no continuity, the cable needs to be replaced.
 - If there is continuity, proceed to CAN Interface Module Test 5.

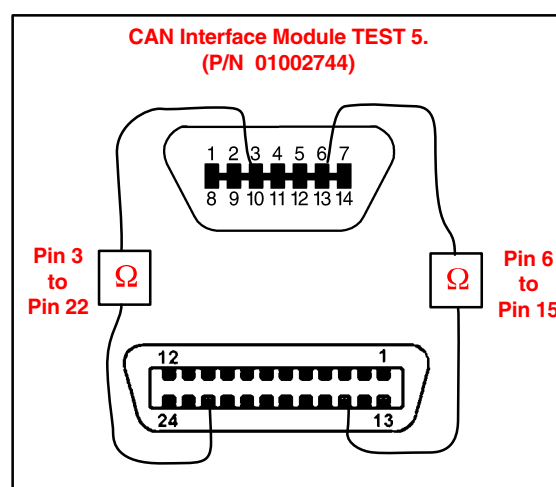
CAN INTERFACE MODULE TEST 5.

- A. Test the CAN Interface Module (P/N 01002744) for continuity.
 - If there is no continuity, the CAN Interface Module needs to be replaced.
 - If there is continuity, the CAN Interface Module is OK. Re-check Cable Tests 1, 2, 3, and 4 while wiggling and flexing the cables.
