# SATURN TAAT INDEX

# INTRODUCTION SATURN TAAT

The Saturn TransAxle Automatic Transmission (TAAT) first appeared in the 1991 Saturn vehicles. The general design of the Saturn automatic transaxle is a parallel shaft front wheel drive transmission which also contains the final drive. The transaxle provides four speeds forward and one reverse using four multiple disc clutches, a four element torque converter with a lock up clutch, 1st gear sprag clutch, and a servo actuated dog clutch. The most significant departure from the traditional automatic transaxle comes from the use of electronic controls. This unit utilizes five electro-hydraulic actuators in conjunction with a powertrain control module (PCM) and it's sensors to control shift timing, shift feel, and provide on-board diagnostics.

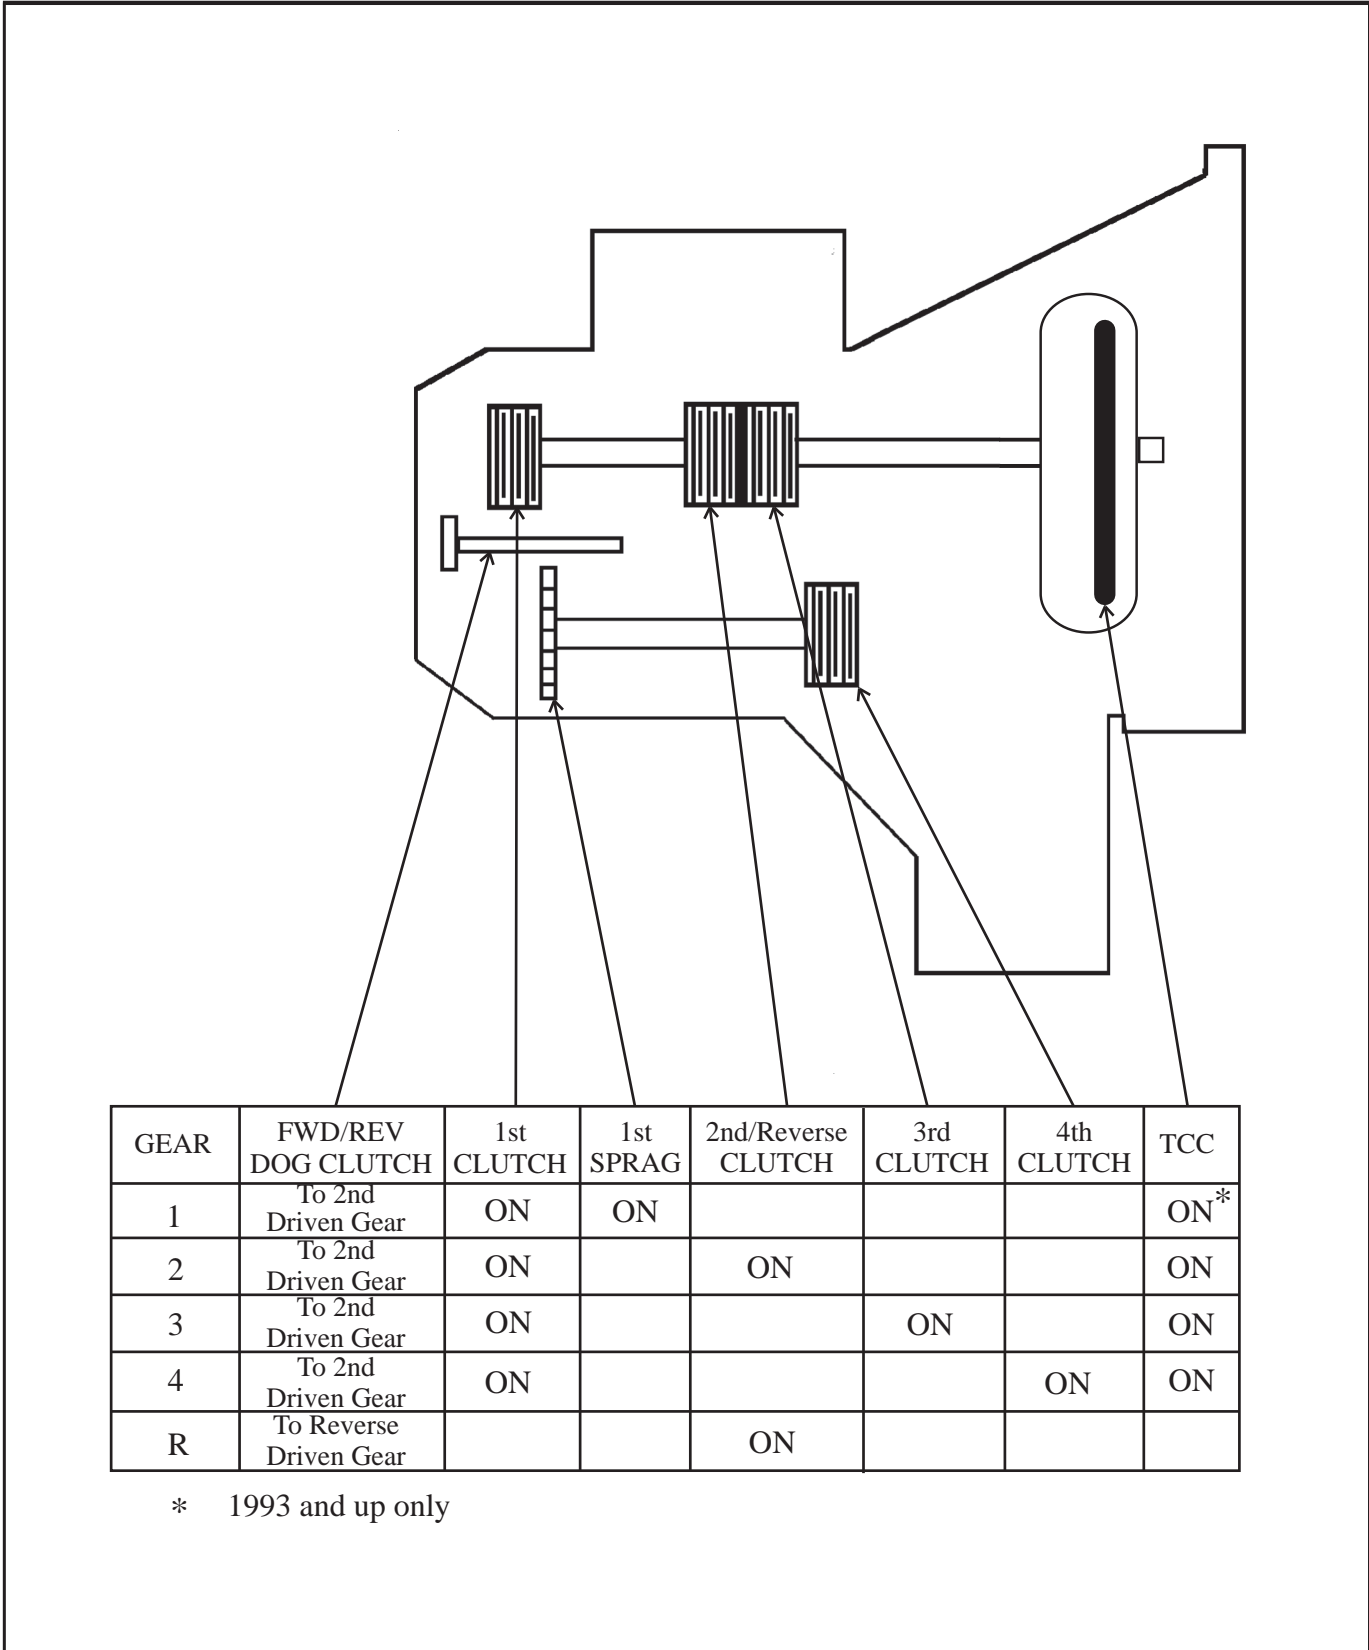
Figure 2

## CLUTCH APPLICATION CHART

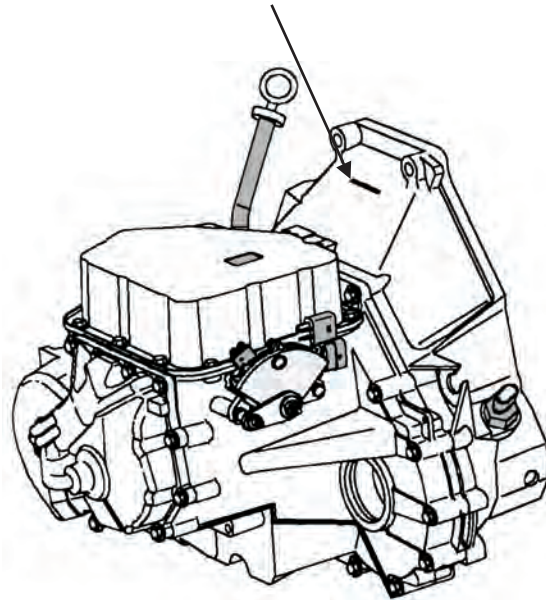
**A STAMPED IDENTIFICATION CODE  
CAN BE FOUND IN THIS AREA**

### IDENTIFICATION CODE BREAKDOWN

- — — — —
1. Model Year (3 = 93)
  2. Model Code: MP2 = Base Manual  
MP3 = Perf. Manual  
MP6 = Auto Base  
MP7 = Auto Perf.
  3. Plant Code (1 = Spring Hill TN)
  4. Julian Date Code (Feb. 12 = 043 day of the year)
  5. Hour of Day: 0 = Midnight      C = Noon
-

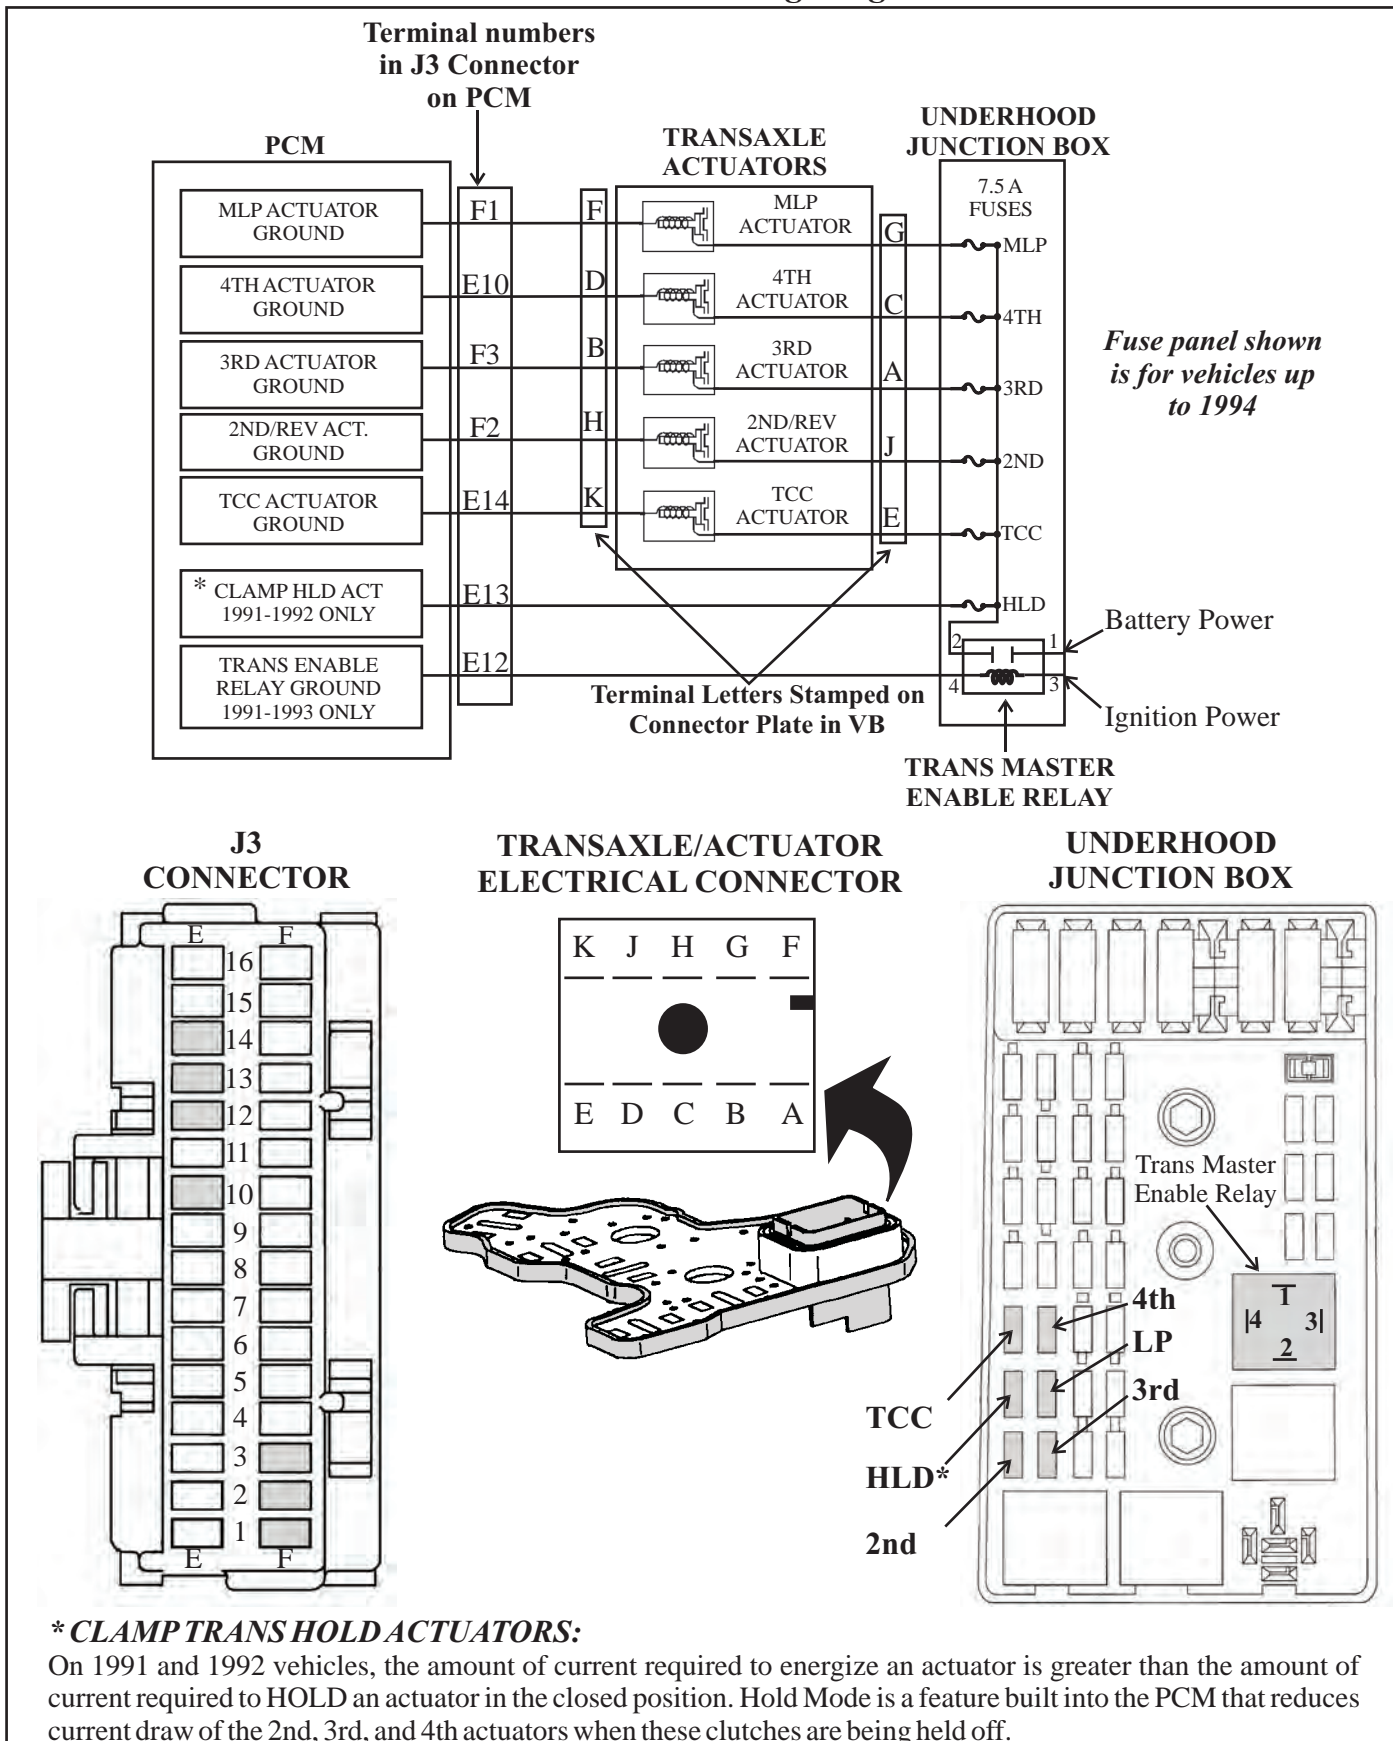
Figure 26

## PCM/Actuators Wiring Diagram

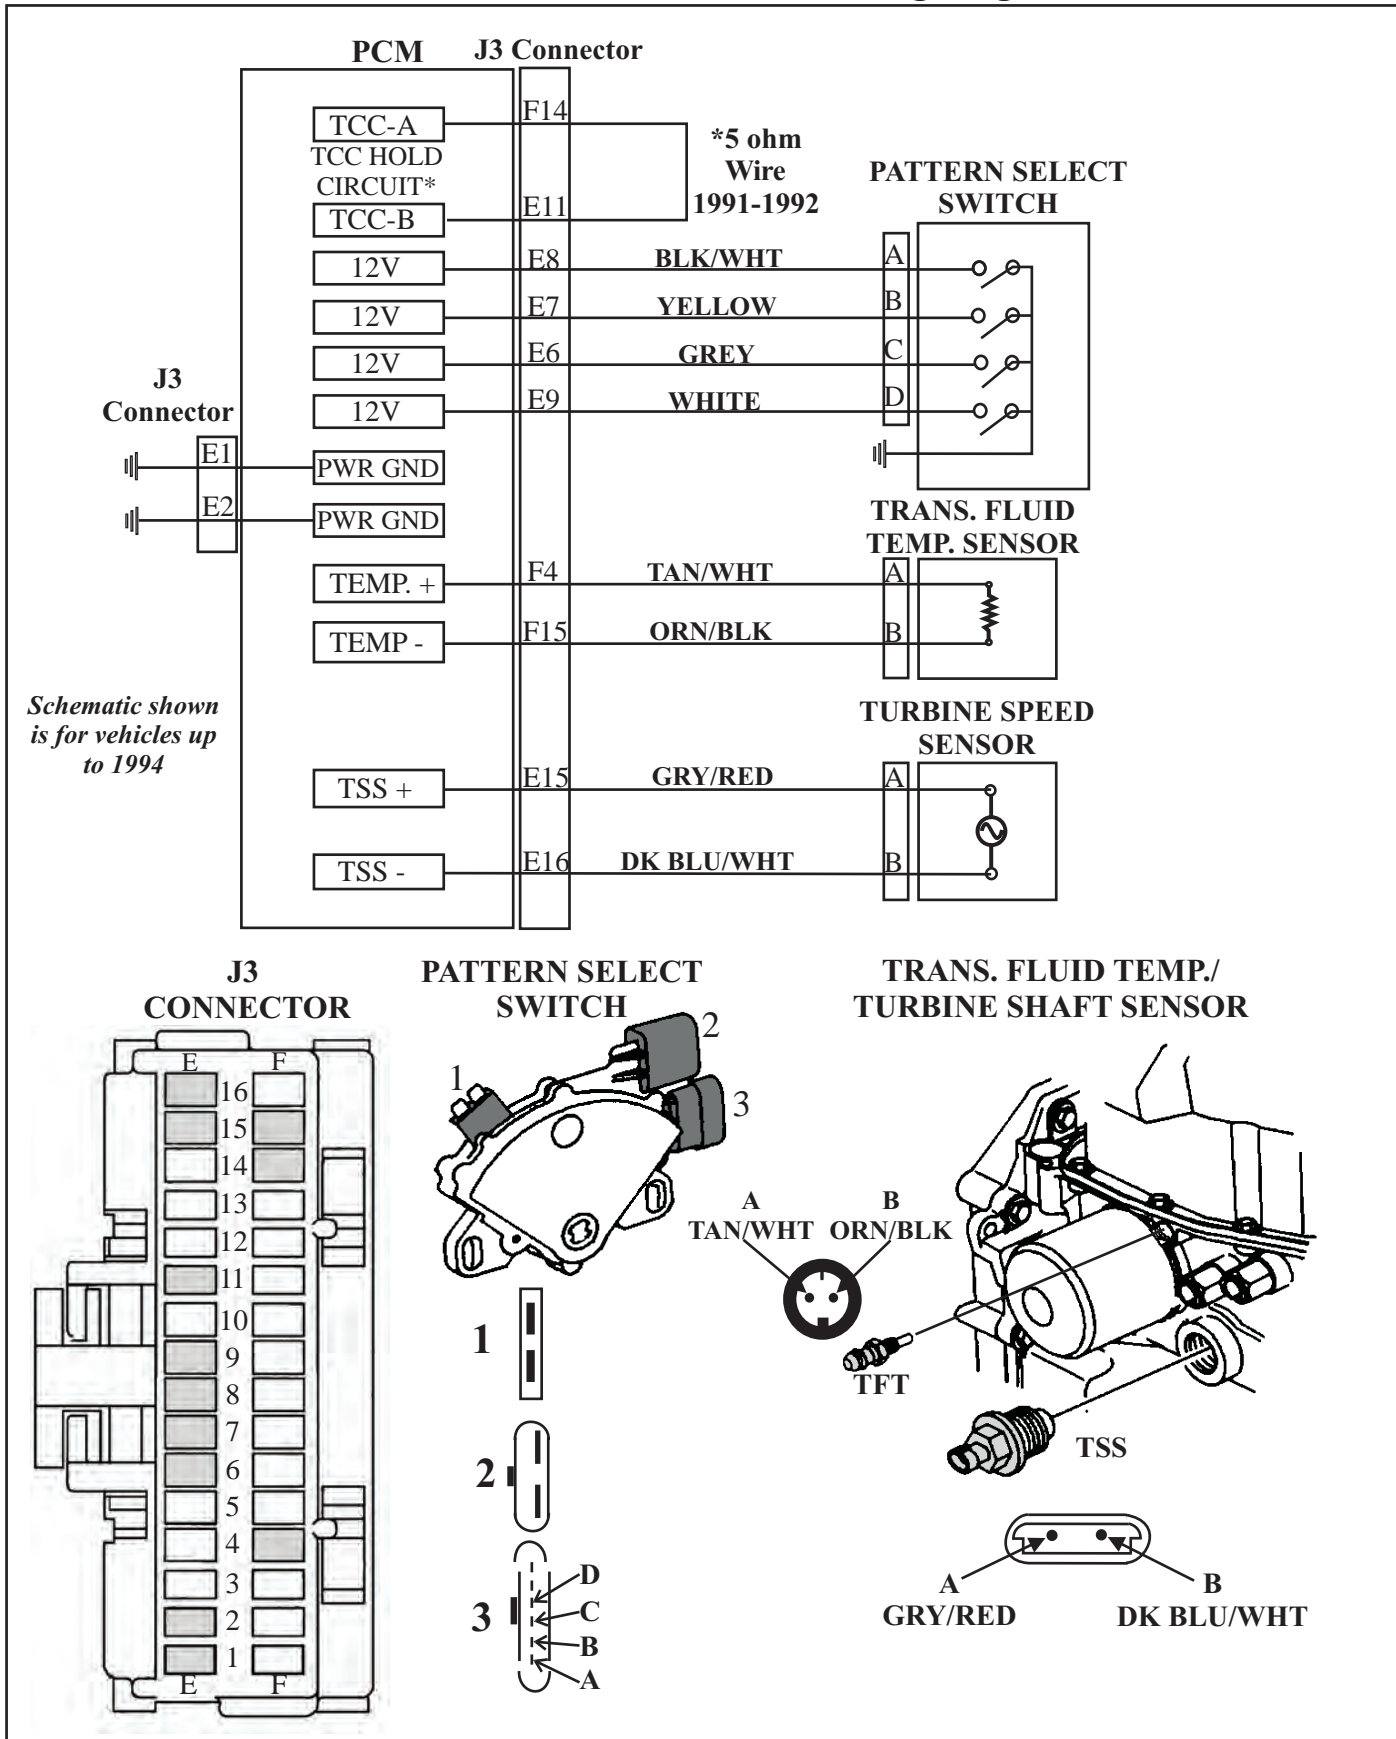
Figure 27

## Pattern Select Switch/TFT/TSS Wiring Diagram

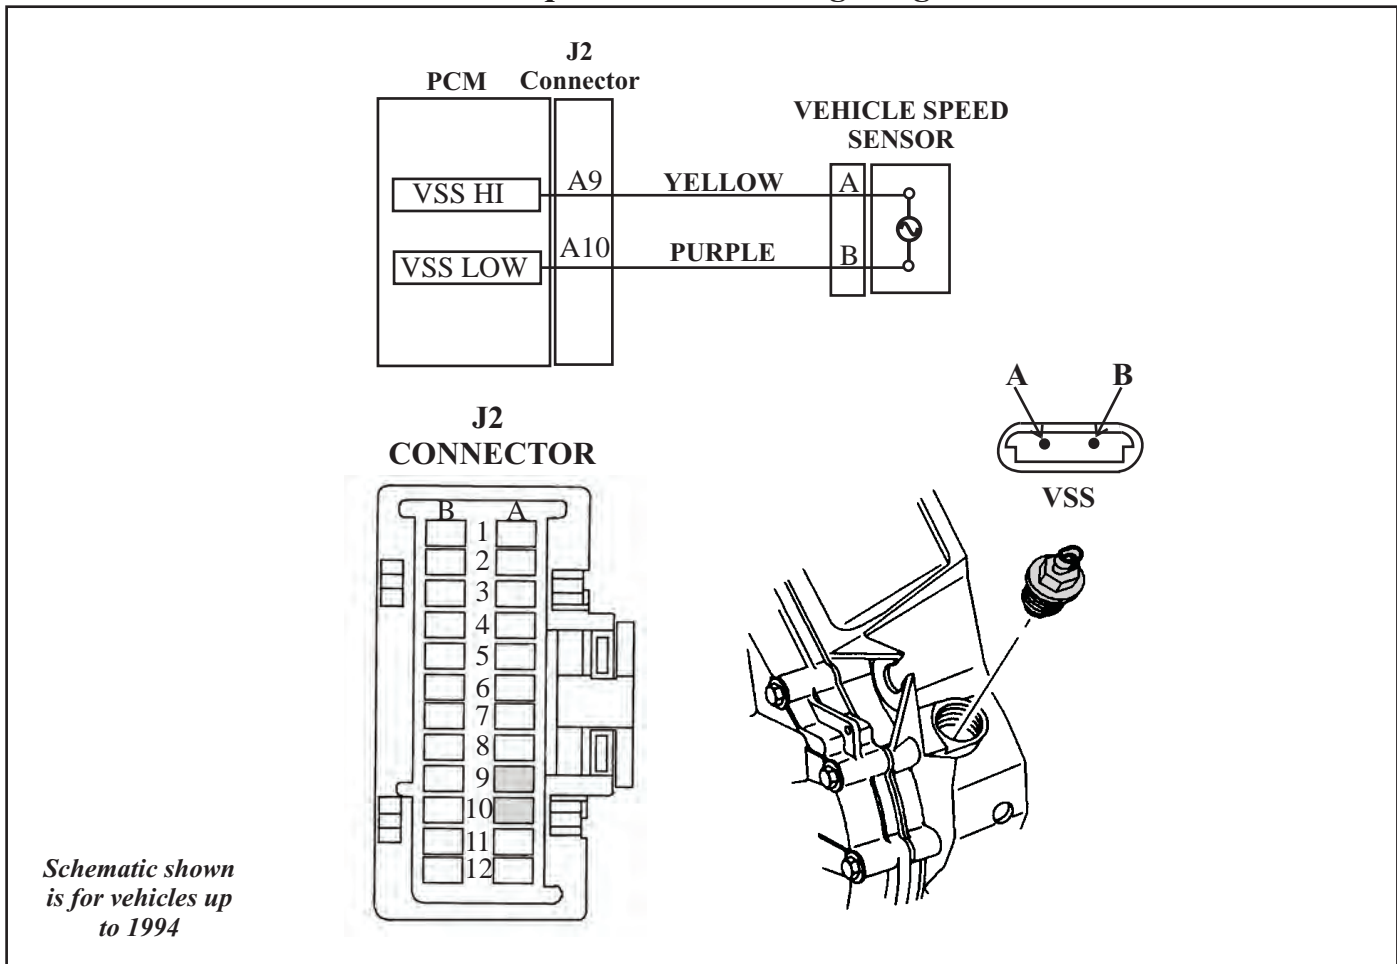
Figure 28

## Vehicle Speed Sensor Wiring Diagram

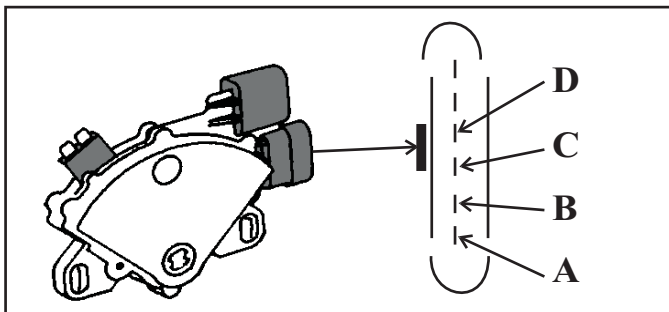
After the Pattern Select Switch has been adjusted, the gear selection can be viewed through a hand held scanner to ensure that the proper signal is being sent to the PCM. If the scanner reveals that the switch is sending an incorrect signal after an adjustment, a check can be made on the switch to determine if the switch is defective or the wiring is defective. Figure 30 below shows a view of a 6 pin connector on the switch where the check is to be made. The bottom pin is terminal A, the next one up is terminal B then C, D, E and F. These letters are molded into the connector along side each of the pins for easy identification. Figure 31 illustrates which pins are suppose to be GROUNDED in P, R, N, D4, D3 and D2. With the switch mounted to the transaxle, place the negative lead of the ohm meter to a good known ground. Place the positive lead onto terminal A. There should be continuity in P, R and D2 only. Repeat the same procedure for each pin utilizing the chart in Figure 31 to determine proper grounding sequence.

<i>Gear Select</i>	<b>A</b>	<b>B</b>	<b>C</b>	<b>D</b>
<b>P</b>	<b>X</b>			<b>X</b>
<b>R</b>	<b>X</b>	<b>X</b>		
<b>N</b>		<b>X</b>		<b>X</b>
<b>D4</b>		<b>X</b>	<b>X</b>	
<b>D3</b>			<b>X</b>	<b>X</b>
<b>D2</b>	<b>X</b>		<b>X</b>	
<b>X = Pin Grounded</b>

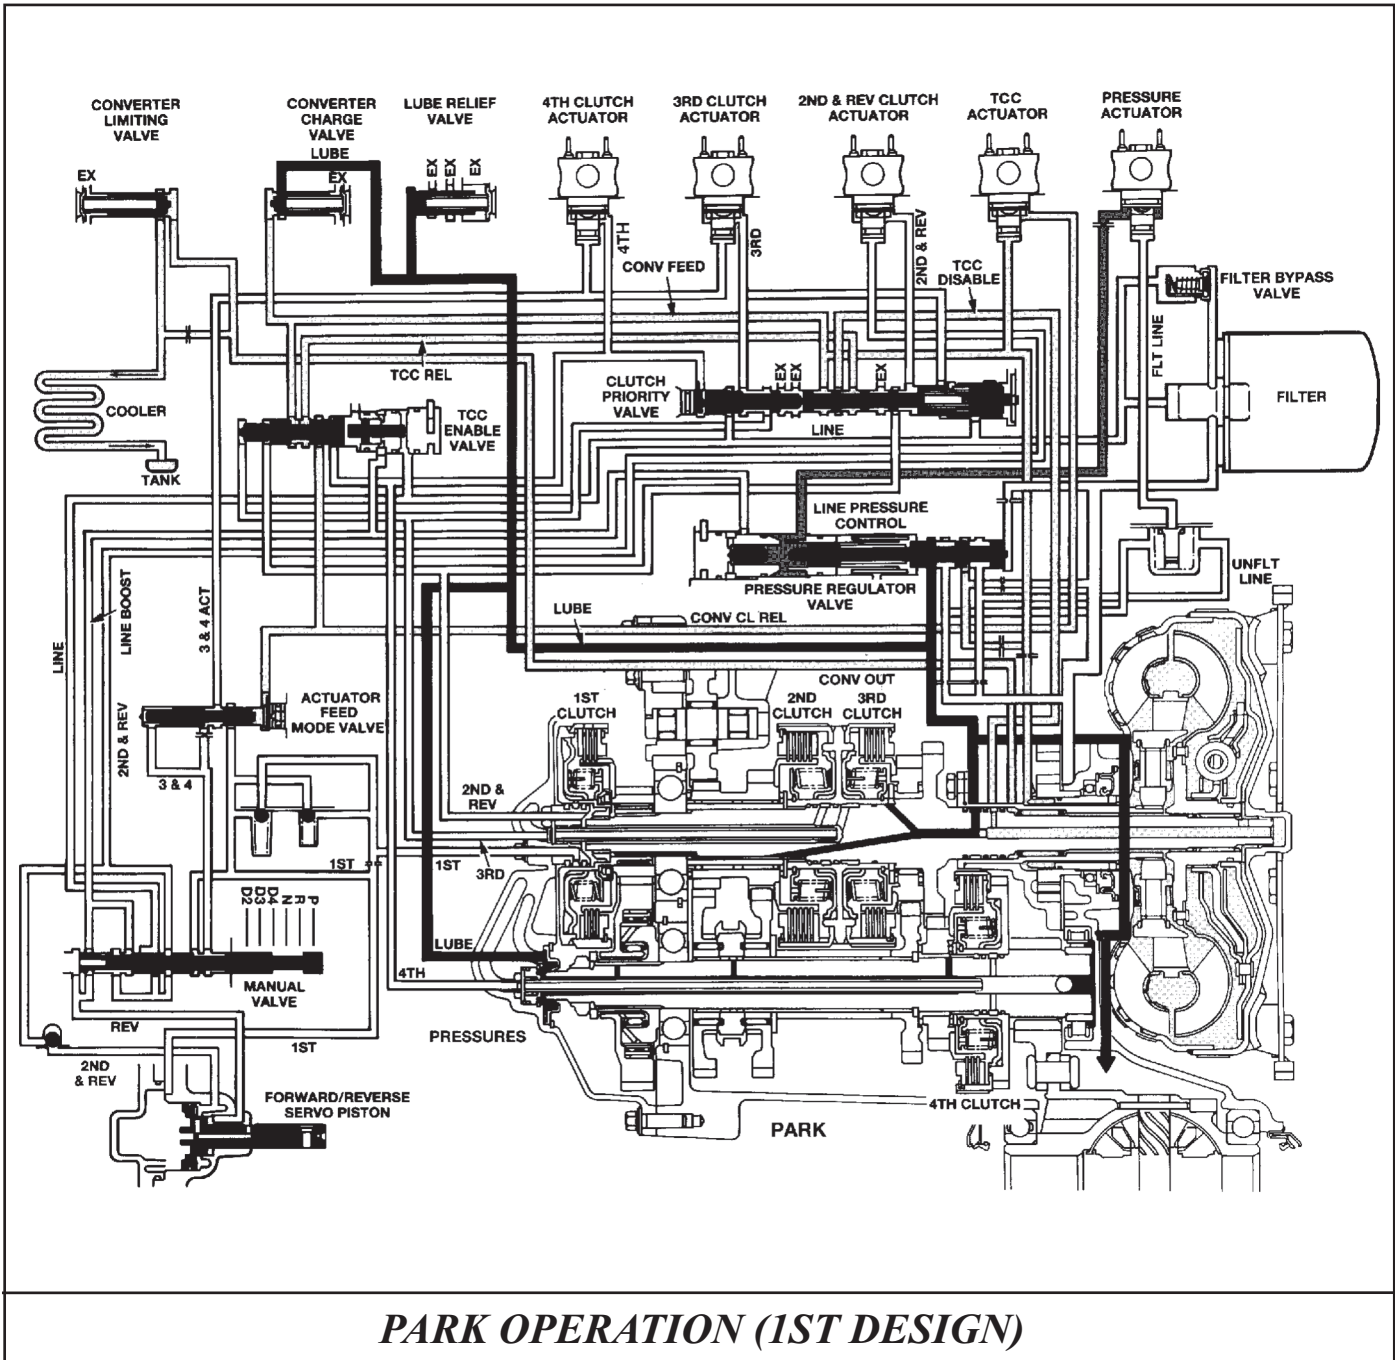
Figure 52

### ***LUBE RELIEF VALVE***

The lube relief valve is located in the pump and exhausts excess lube lube pressure to the suction side of the pump.

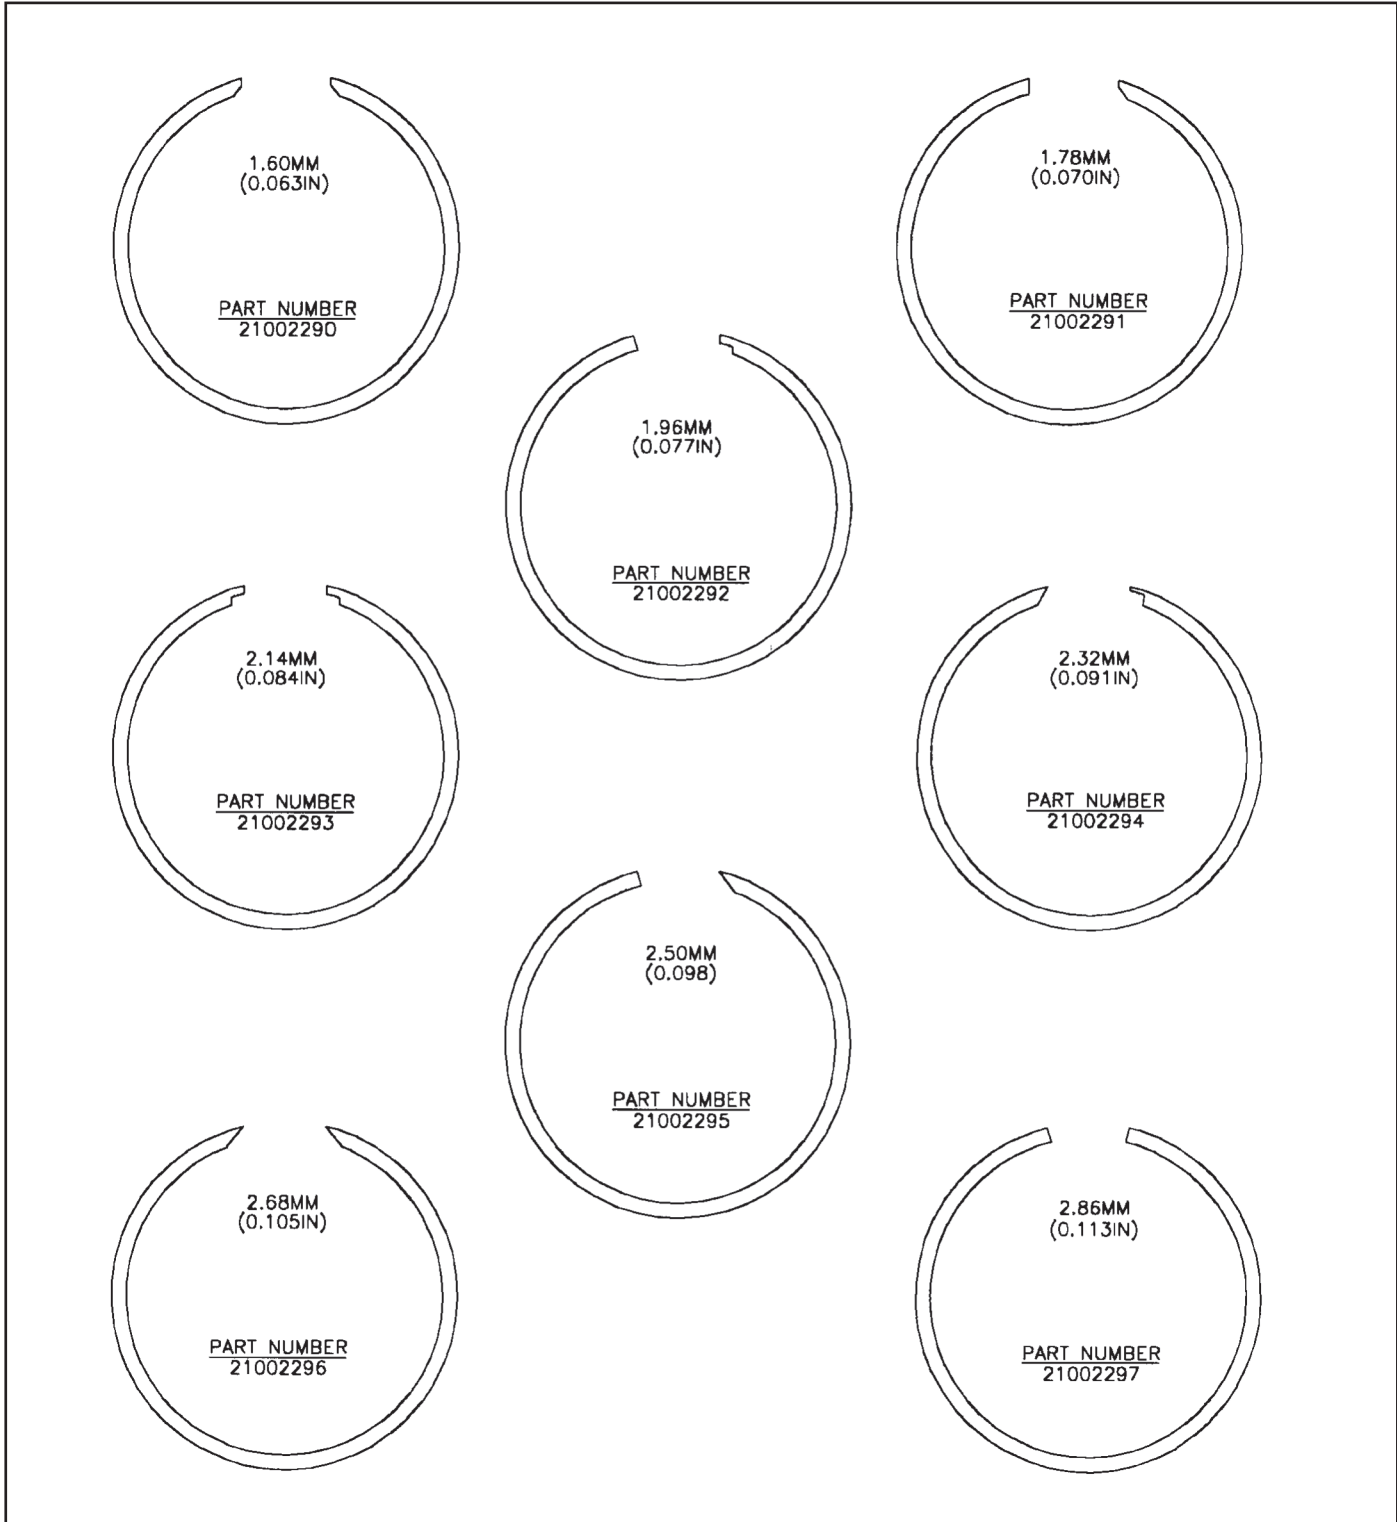
Figure 118

The selective backing plate snap ring is used to adjust all four clutch pack assemblies. Each snap ring below can be identified by the different tip or end configuration. If a clutch pack is either to loose or to tight, determine the proper thickness snap ring to bring the adjustment within the factory specifications.

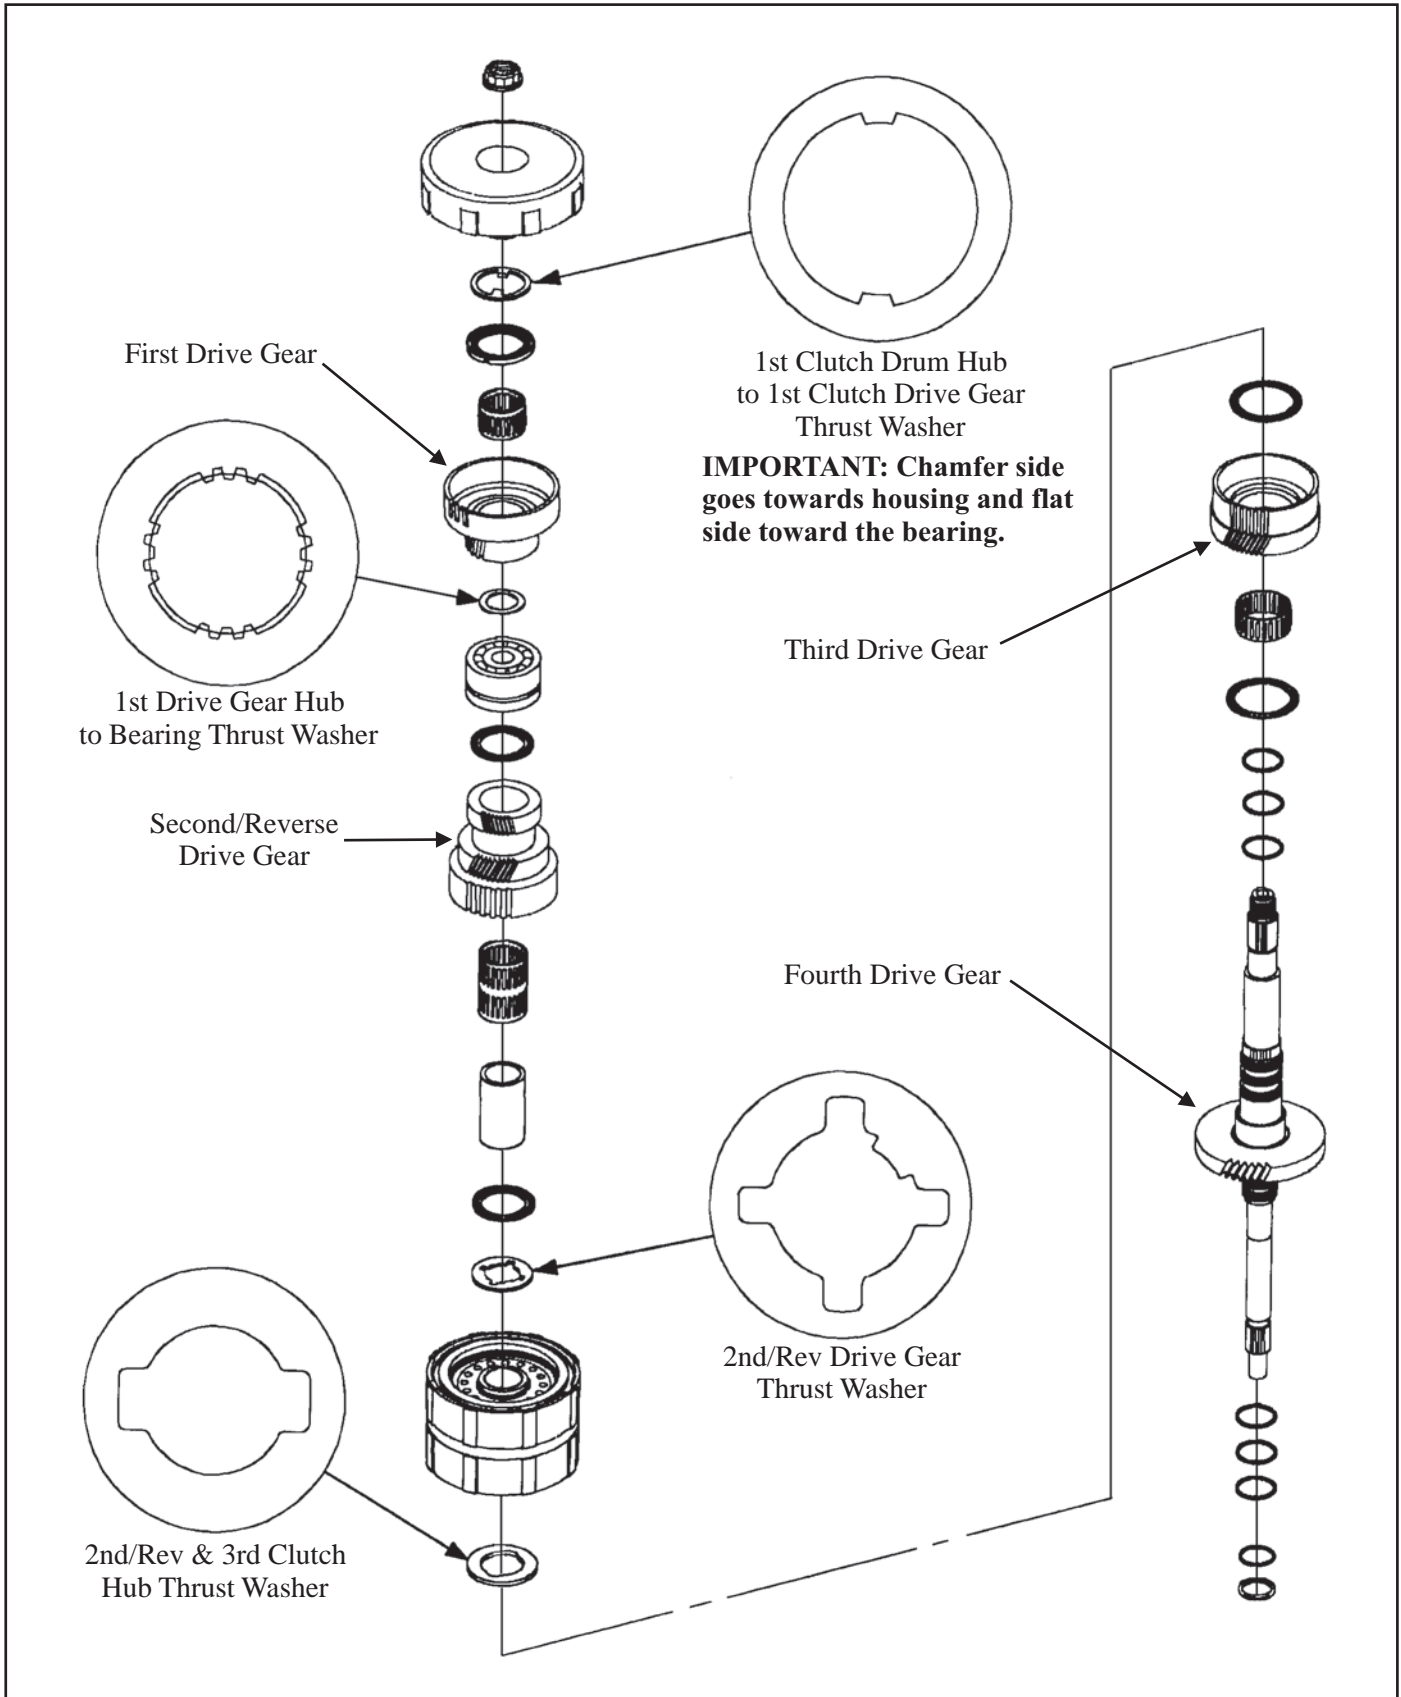
Figure 122

**INPUT SHAFT ASSEMBLY AND THRUST WASHER OVERVIEW**

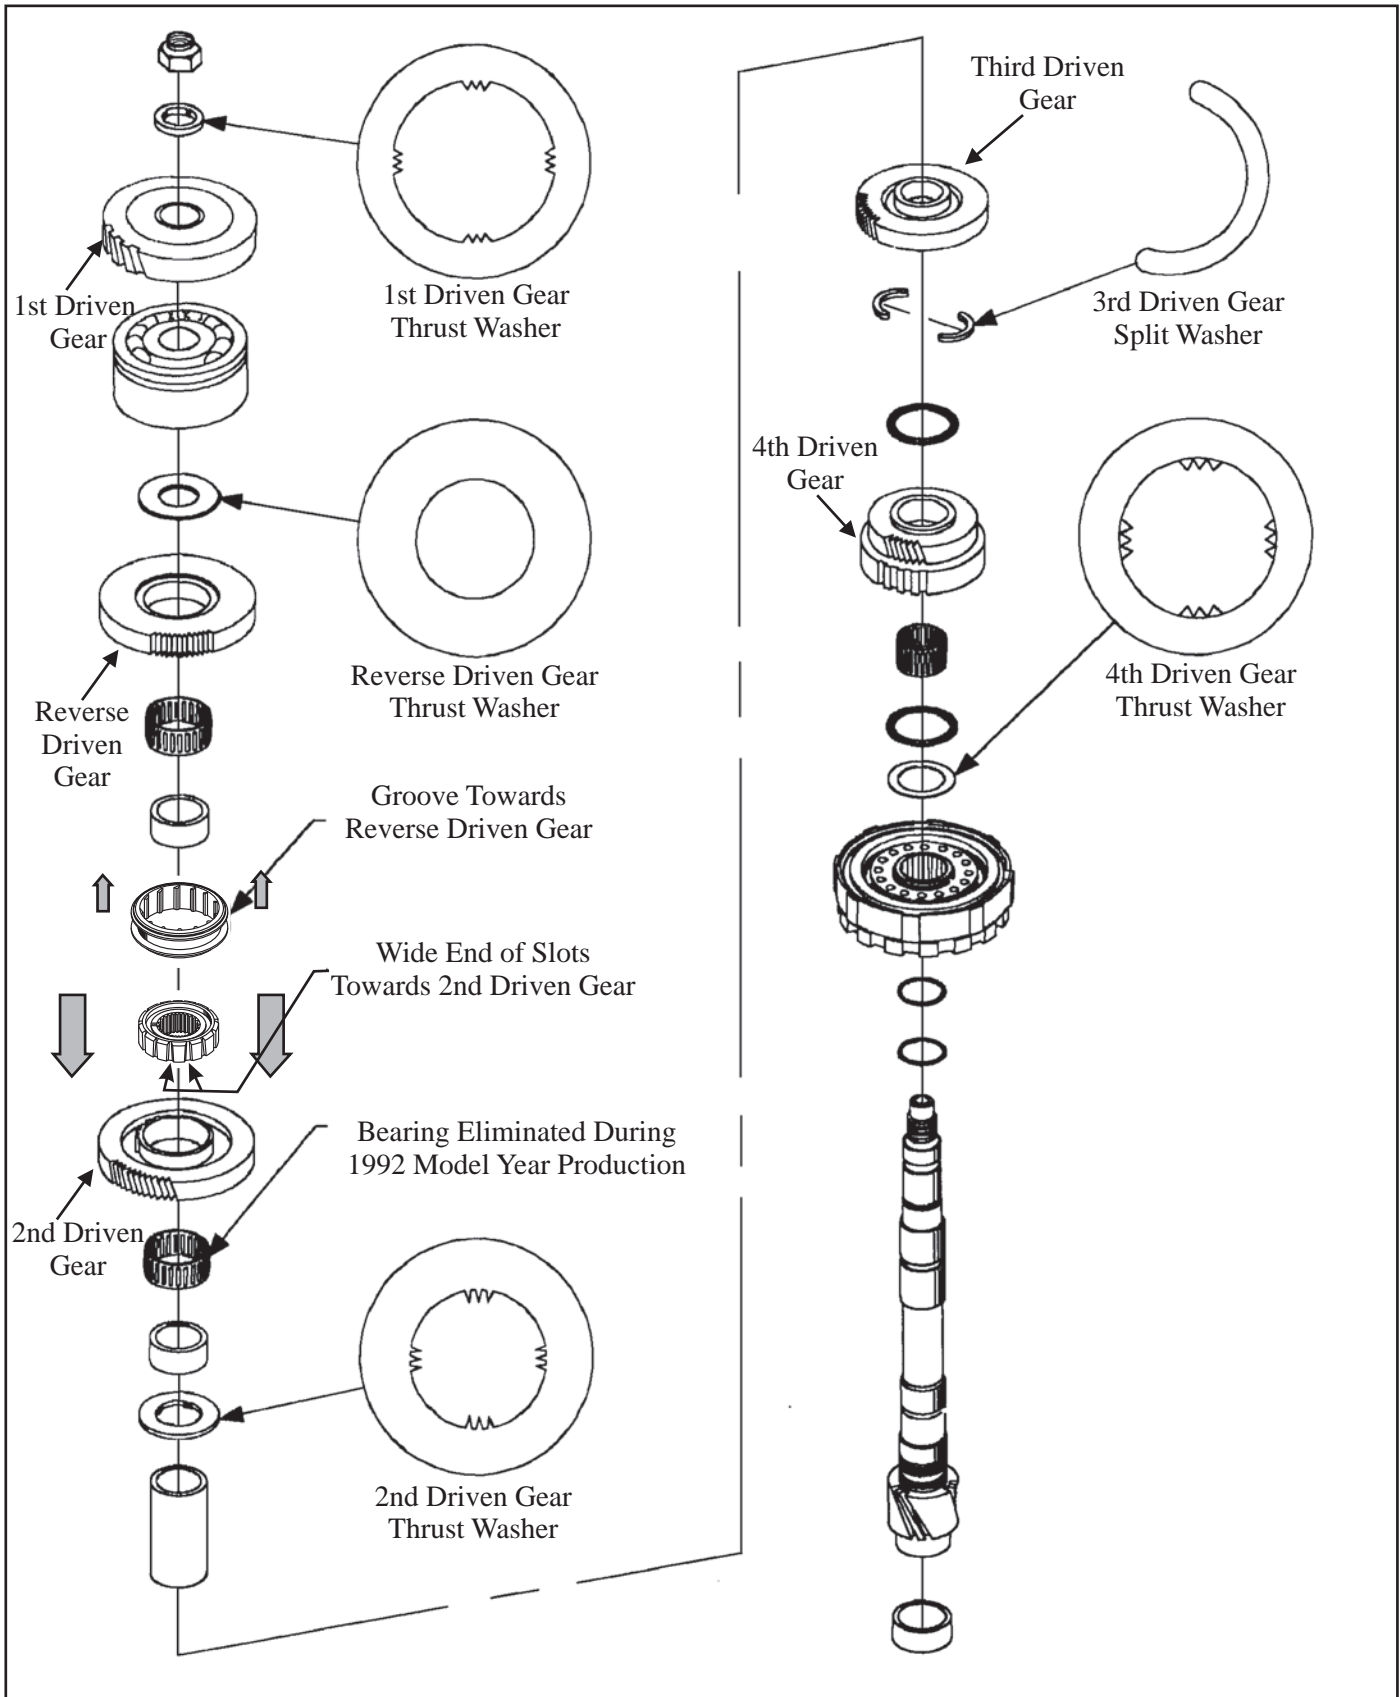
Figure 135

## OUTPUT SHAFT ASSEMBLY AND THRUST WASHER OVERVIEW

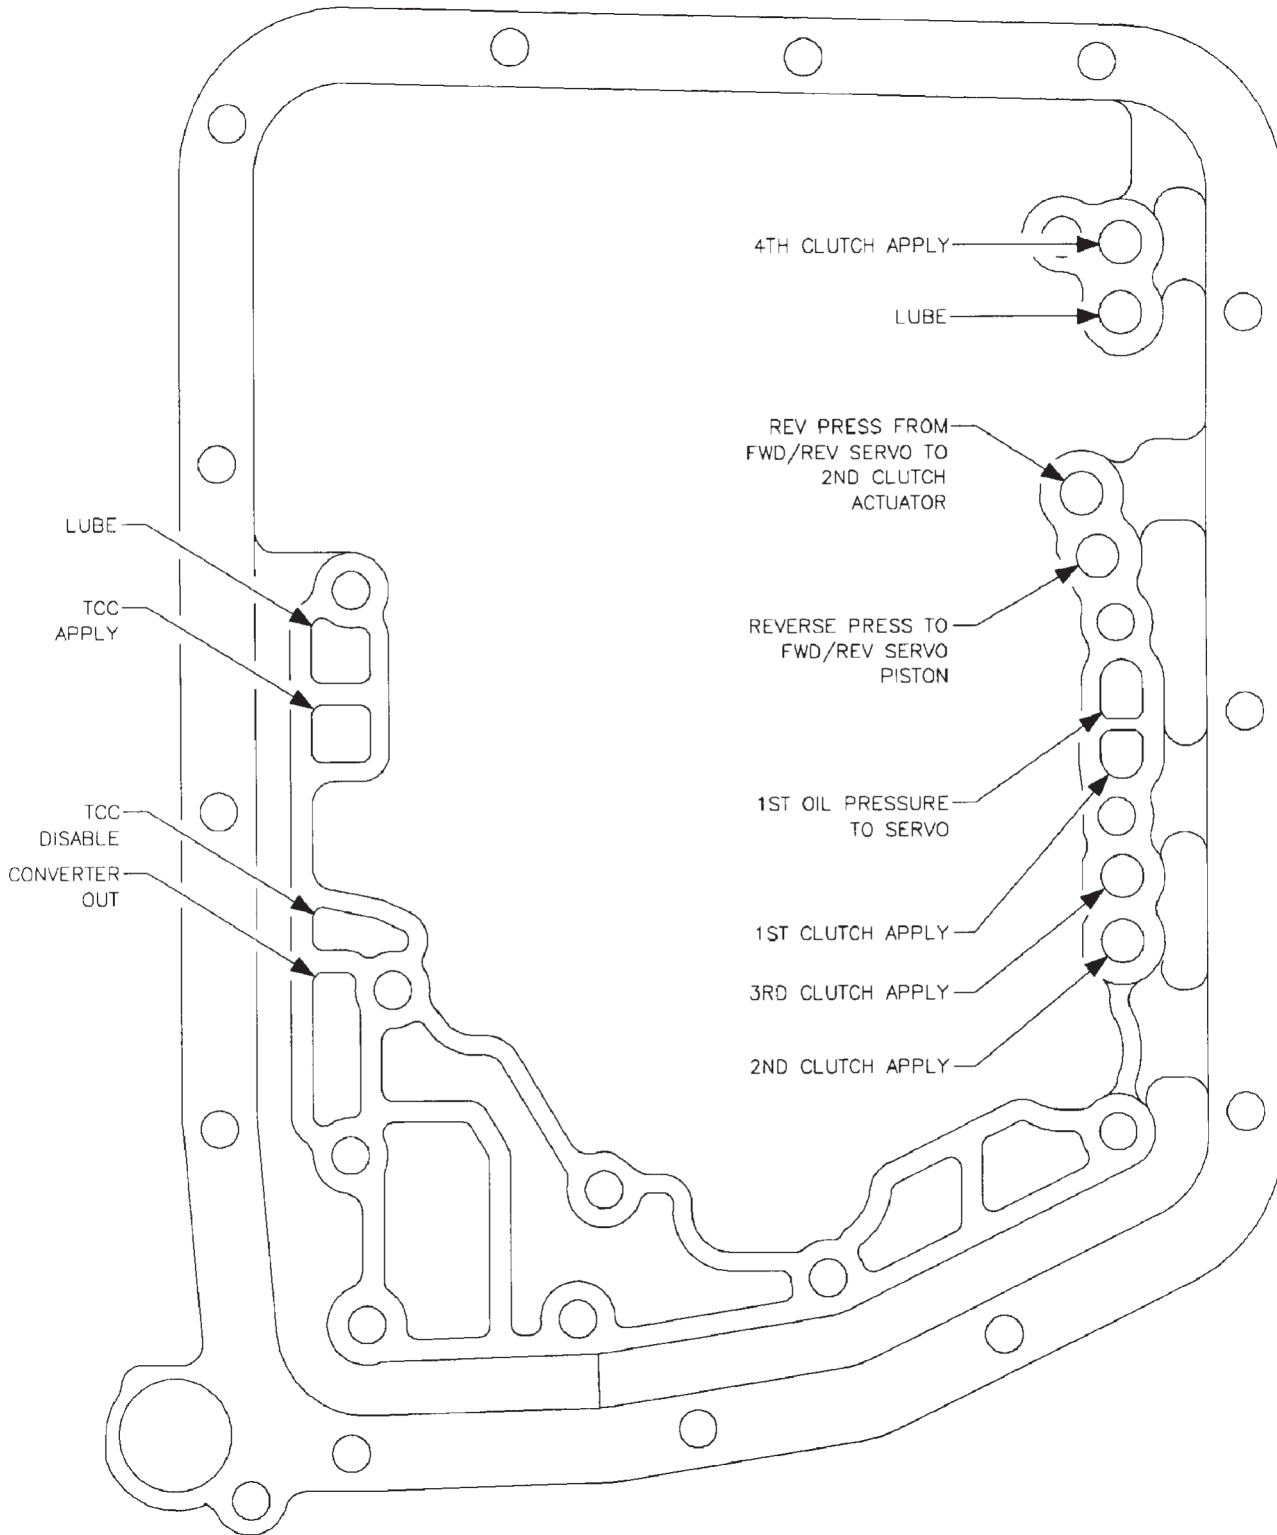
Figure 212

***AIR PRESSURE TEST PORTS  
1ST DESIGN CASE***

***AIR PRESSURE TEST PORTS  
2ND DESIGN CASE***

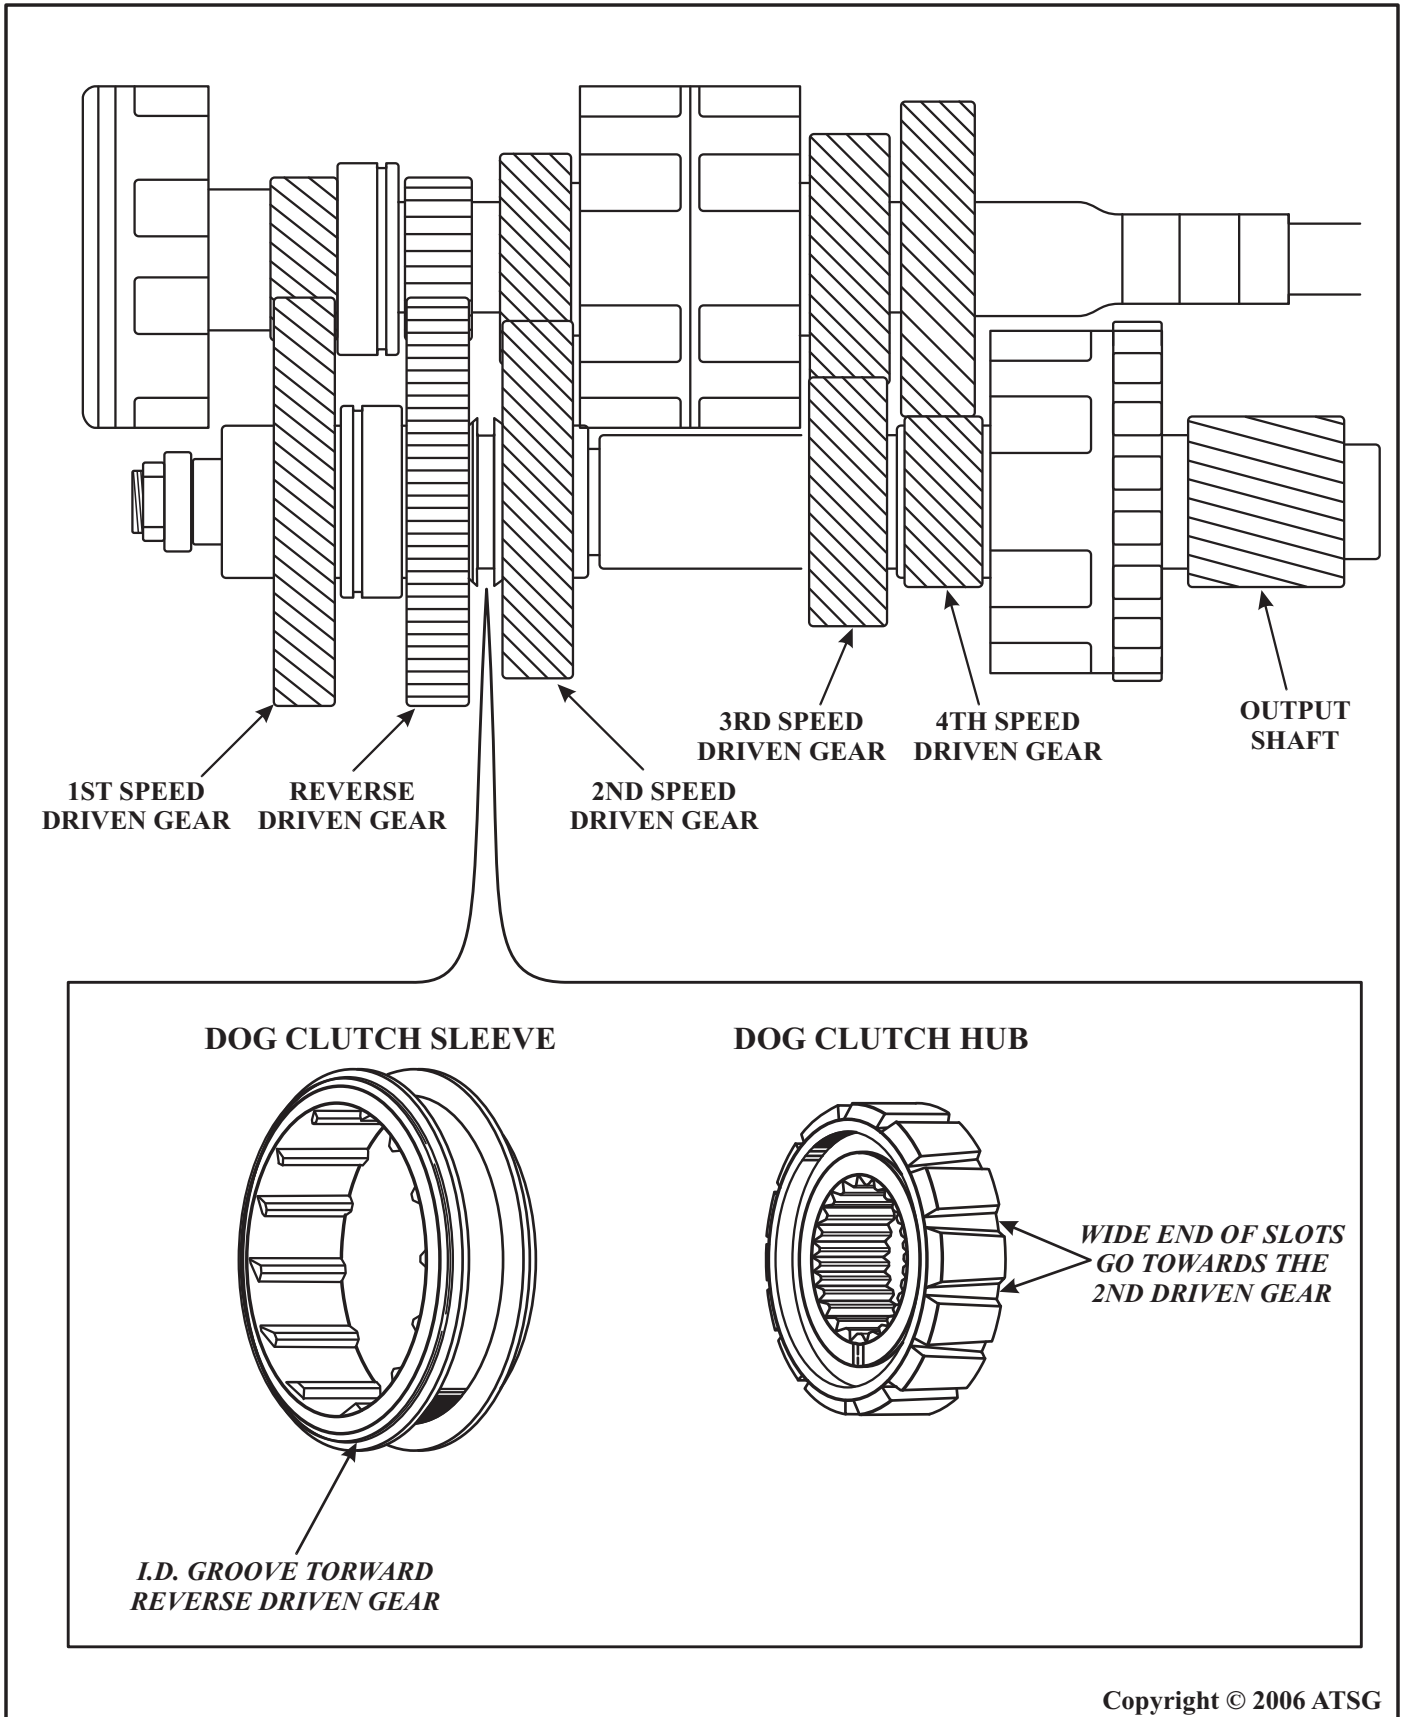
Figure 2

**CORRECTION:** The Dog Clutch Hub *must* be installed with the "Wide" end of the "Slots" towards the 2nd Driven Gear, as shown in Figure 2.  
The Dog Clutch Sleeve *must* be installed with the I.D. groove towards the Reverse Driven Gear, as shown in Figure 2.
