# SATURN TAAT INDEX

# INTRODUCTION SATURN TAAT

The Saturn TransAxle Automatic Transmission (TAAT) first appeared in the 1991 Saturn vehicles. The general design of the Saturn automatic transaxle is a parallel shaft front wheel drive transmission which also contains the final drive. The transaxle provides four speeds forward and one reverse using four multiple disc clutches, a four element torque converter with a lock up clutch, 1st gear sprag clutch, and a servo actuated dog clutch. The most significant departure from the traditional automatic transaxle comes from the use of electronic controls. This unit utilizes five electro-hydraulic actuators in conjunction with a powertrain control module (PCM) and it's sensors to control shift timing, shift feel, and provide on-board diagnostics.

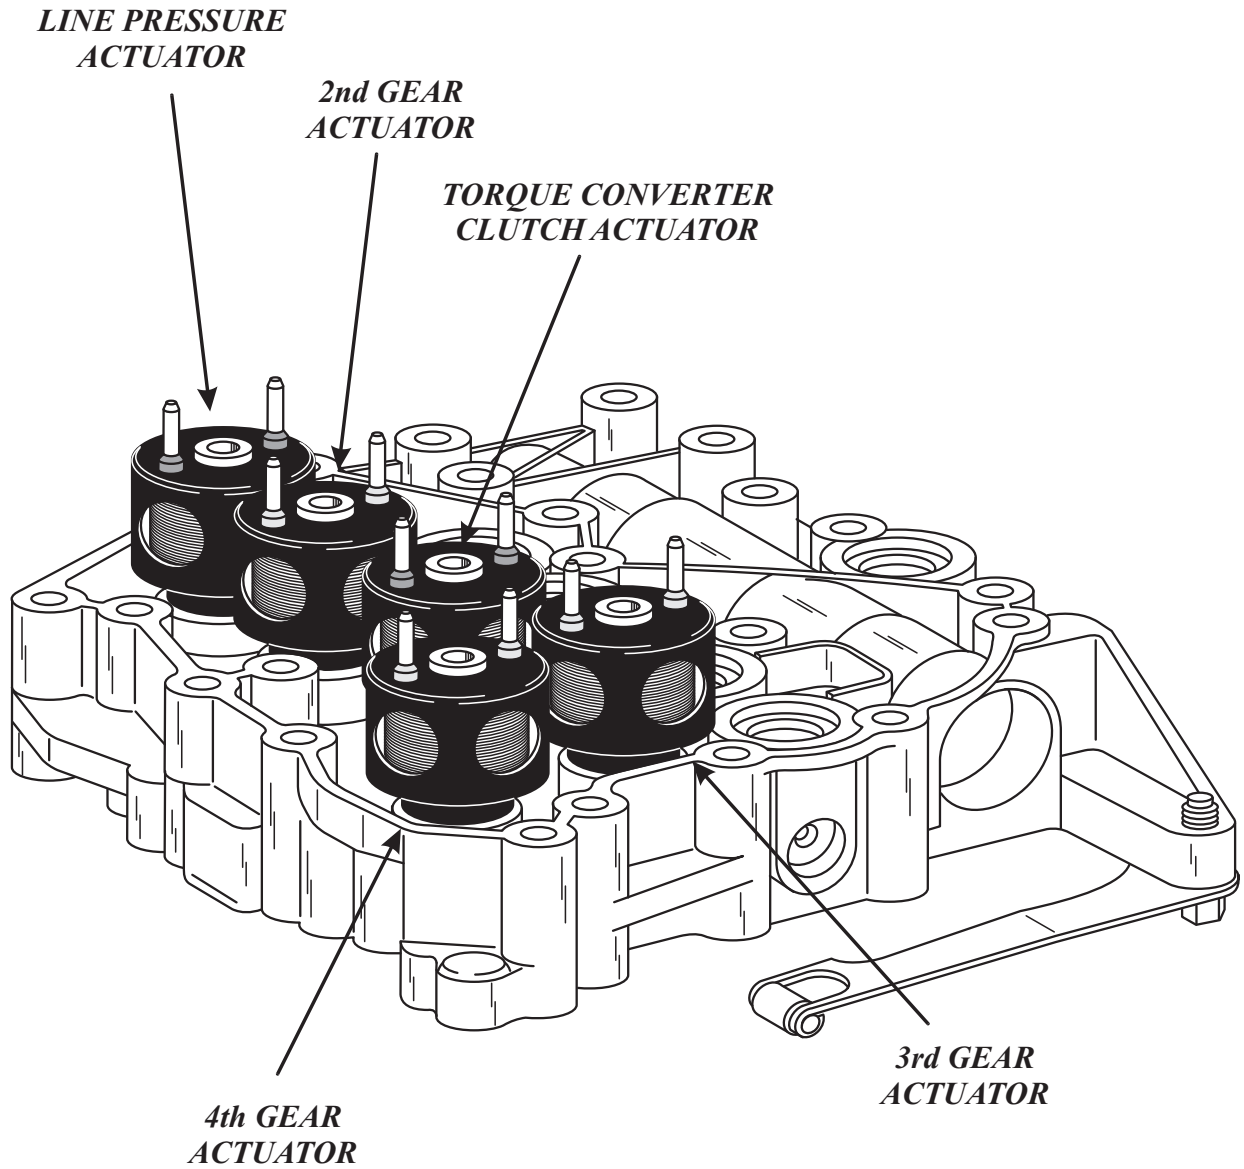
Figure 4

**SATURN VALVE BODY  
ACTUATOR LOCATIONS**

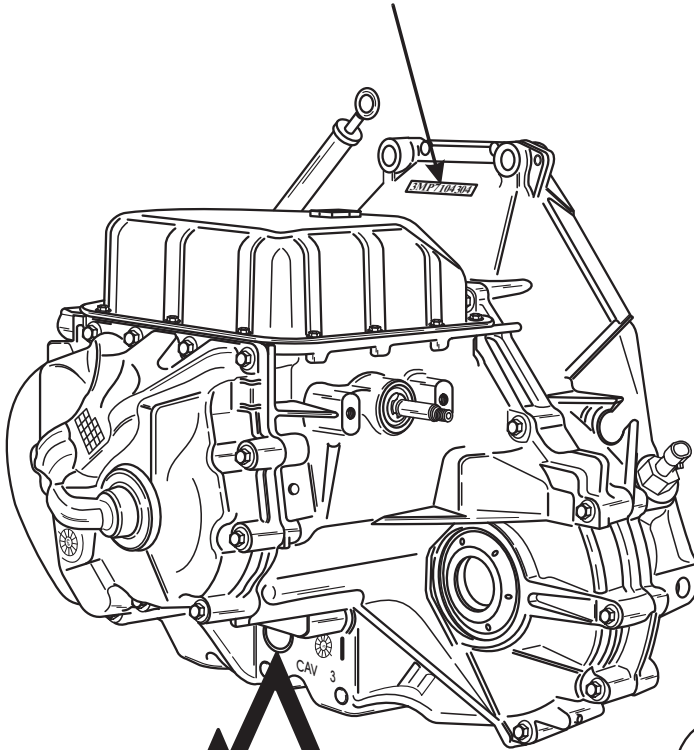
**STAMPED IDENTIFICATION CODE  
CAN BE FOUND IN THIS AREA**

**IDENTIFICATION CODE DESCRIPTION**
